Rehabilitation of a DN 400 GRP irrigation pipe under the main road towards Palm Jumeirah

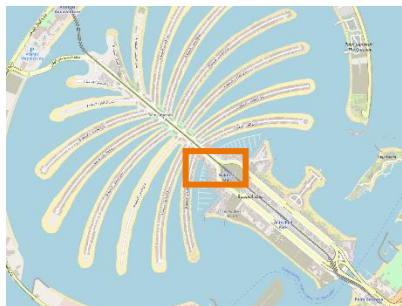
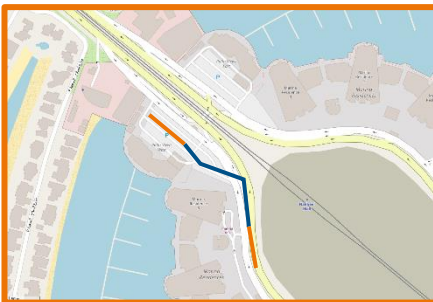
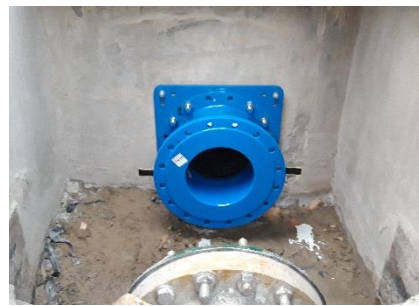
An existing GRP DN 400 irrigation pipe was leaking due to soil settling. This water main is crossing one of the major roads towards the Palm Jumeirah road in Dubai with two 45 degree bends. Traditional open trench excavation was not feasible. Moreover, the water main is only accessible via small maintenance chambers – one located directly in the road, the other at an adjacent parking lot. The fittings in the chambers were removed and the host pipe was cut flush with the wall of the chamber to create the necessary working space. After cleaning the host pipe, a CCTV inspection was performed. The pre-folded DN 400 Primus Liner was inserted in 15 minutes and re-rounded. Due to the confined space situation, the connectors were specifically produced for this project and equipped with a wall-mounting plate to fix to the chamber’s wall. A hydrostatic pressure test was successfully performed after the renovation works. The entire rehabilitation was completed in two night shifts.
